# Your Inspection Report

24 Trillium Trail, Suite Coldwater  
Coldwater, ON L0K 1E0

**INSPECTION DATE:**  
Friday, November 29, 2013

Milltown Home Inspections  
24 Trillium Trail RR4, Suite Coldwater  
Ontario, ON L0K 1E0

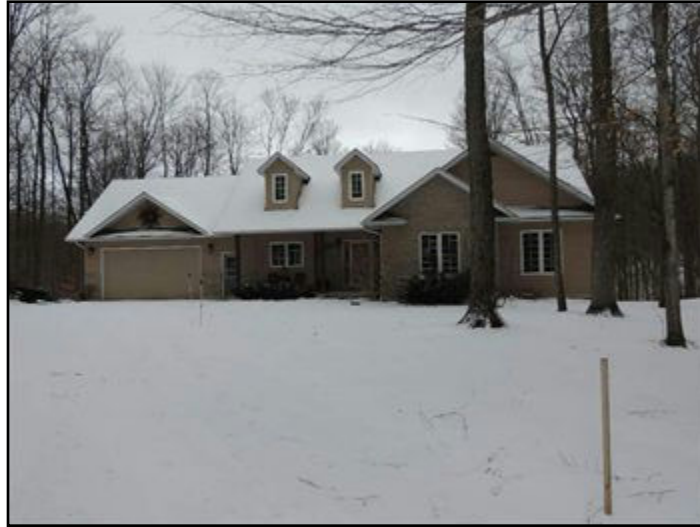
1.

**1. Condition:** • Shingles are approximately halfway thru life expectancy and have some darkening due to lack of drying from sun as faces north

**Location:** North

**Task:** Monitor

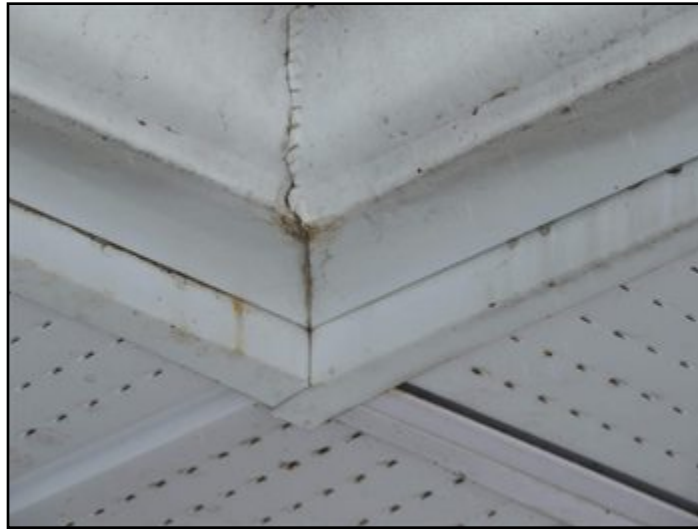
**2. Condition:** • [Leak](#)

**Implication(s):** Chance of water damage to contents, finishes and/or structure

**Location:** Various

2. Leak

**Task:** Correct Service annually

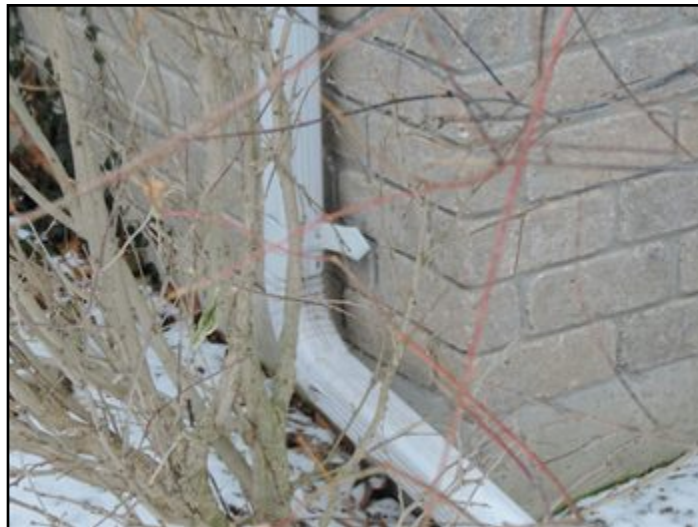
3. Condition: • [Loose connections](#)

Implication(s): Leakage

Location: North South

3. Loose or damaged

Task: Correct

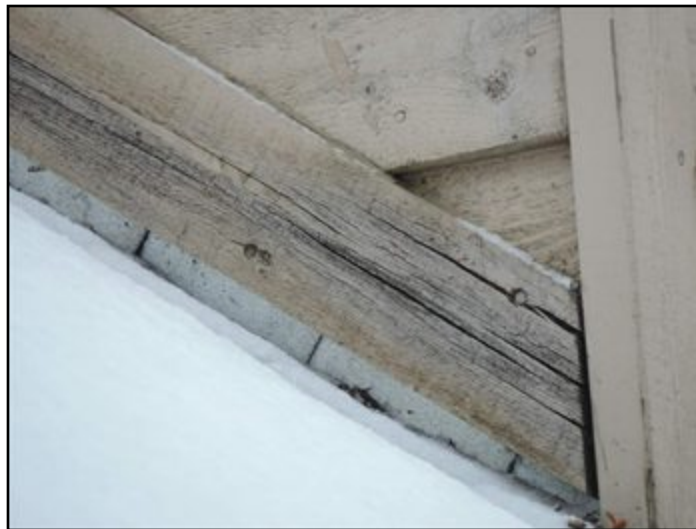
### **4. Condition:** • [Cracked, split or broken](#)

Dormer siding has minor splitting and rot from snow

**Implication(s):** Cosmetic defects | Chance of water damage to contents, finishes and/or structure

**Location:** Northeast Exterior

*4. Cracked, split or broken*

**Task:** Monitor

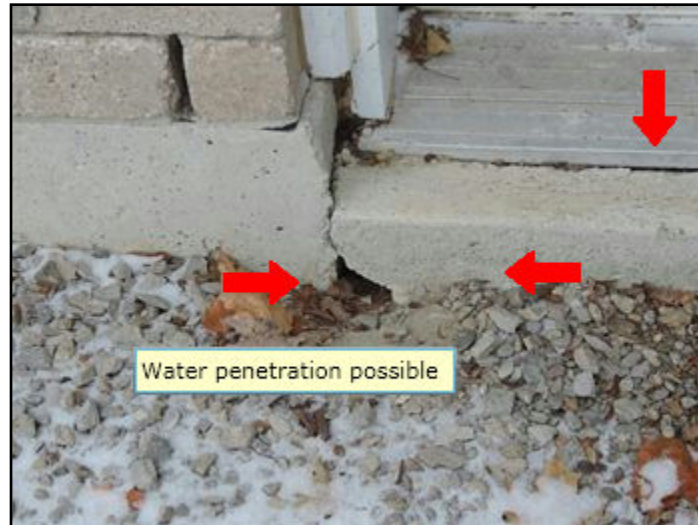
5. Poured concrete

Man door at Garage requires caulking at foundation to stop water penetration

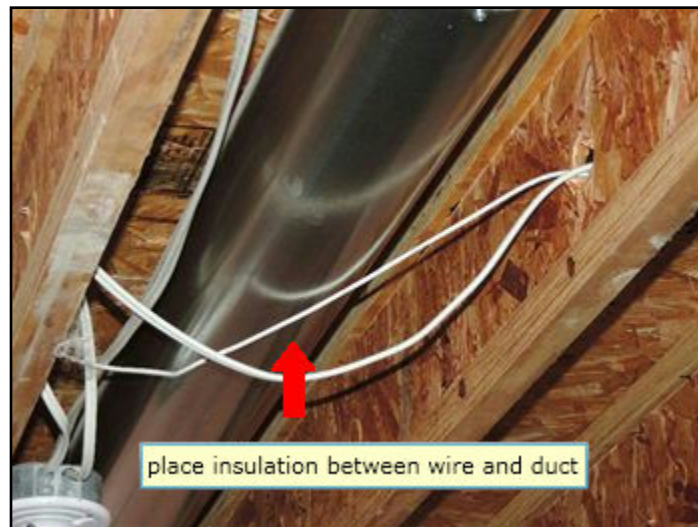
**5. Condition:** • [Too close to ducts, pipe, chimneys, etc.](#)

**Implication(s):** Electric shock | Fire hazard

**Location:** Utility Room

8. Too close to ducts, pipe, chimneys, etc.

**Task:** Improve

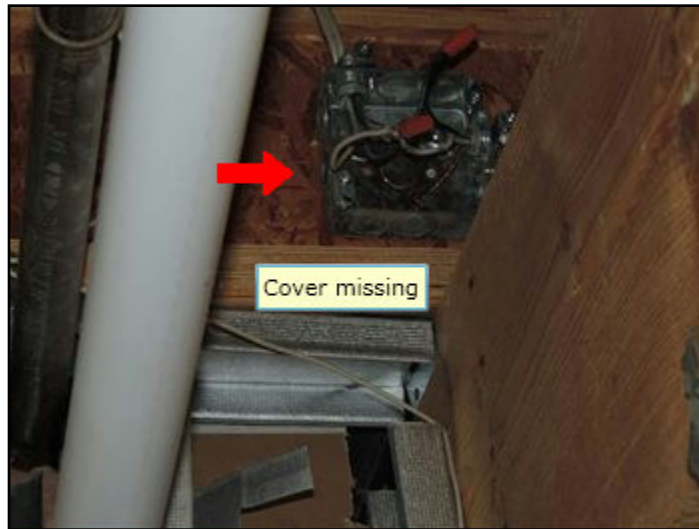
6. Condition: • [Cover loose or missing](#)

Implication(s): Electric shock | Fire hazard

Location: Basement Utility Room

9. Cover loose or missing

Task: Provide

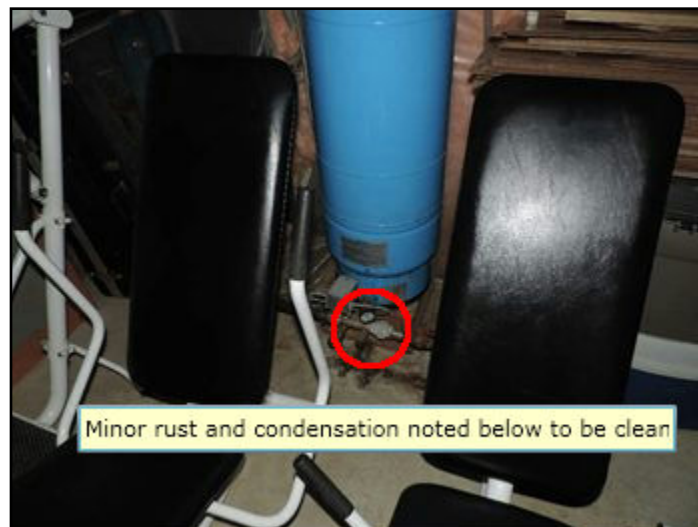
**10. Condition:** • [Rust](#)

**Implication(s):** Chance of water damage to contents, finishes and/or structure | Difficult to service

**Location:** Basement Utility Room

11. *Rust*

**Task:** Clean Monitor

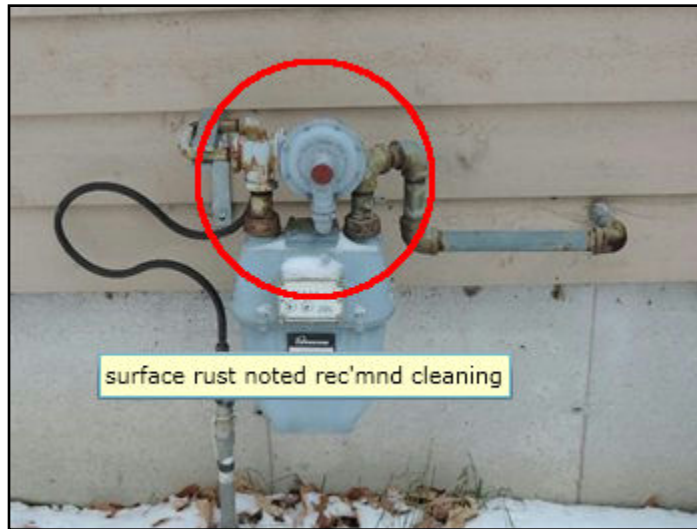
**11. Condition:** • [Rust](#)

**Implication(s):** Reduced system life expectancy | Equipment not operating properly

**Location:** West

12. Rust

**Task:** Clean

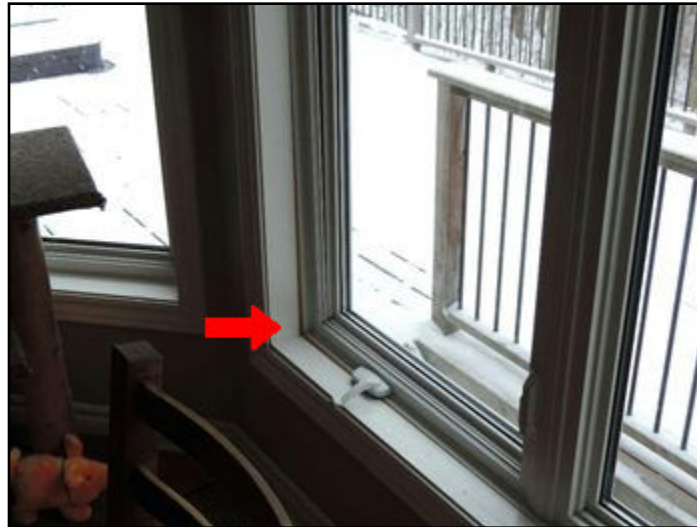
**12. Condition:** • [Deformation](#)

**Implication(s):** Chance of damage to finishes and structure

**Location:** South Dining Room

13. Deformation

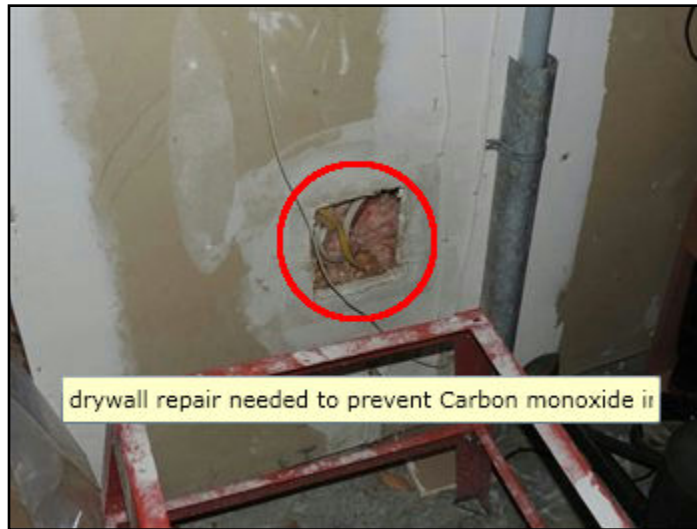
13. Condition: • [Not gastight](#)

Implication(s): Hazardous combustion products entering home

Location: Garage

14. Not gastight
