# Your Inspection Report

24 Trillium Trail, Suite Coldwater  
Coldwater, ON L0K 1E0

**INSPECTION DATE:**  
Friday, November 29, 2013

Milltown Home Inspections  
24 Trillium Trail RR4, Suite Coldwater  
Ontario, ON L0K 1E0

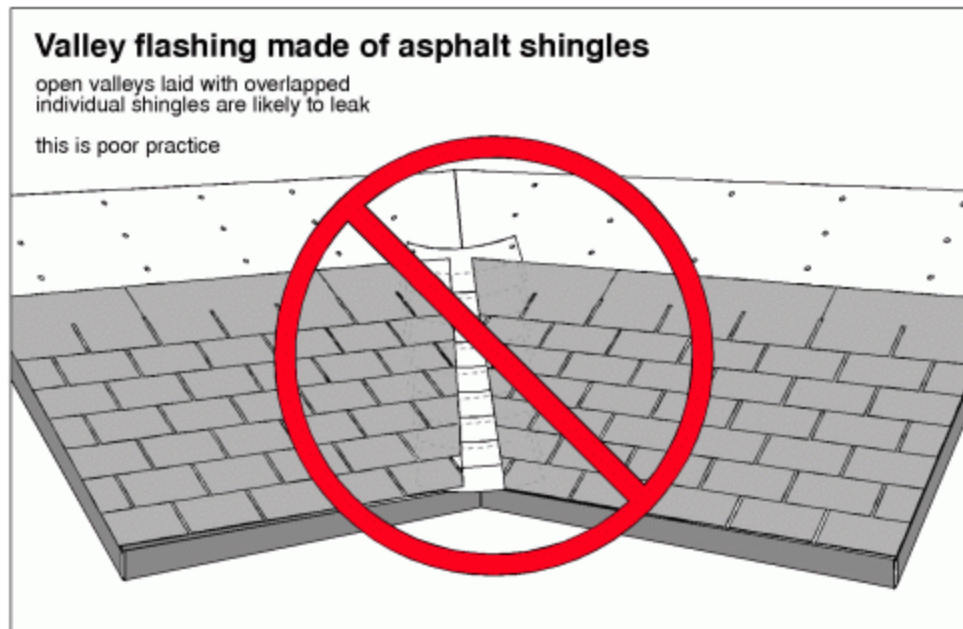
**Condition:** • Shingles are approximately halfway thru life expectancy and have some darkening due to lack of drying from sun as faces north

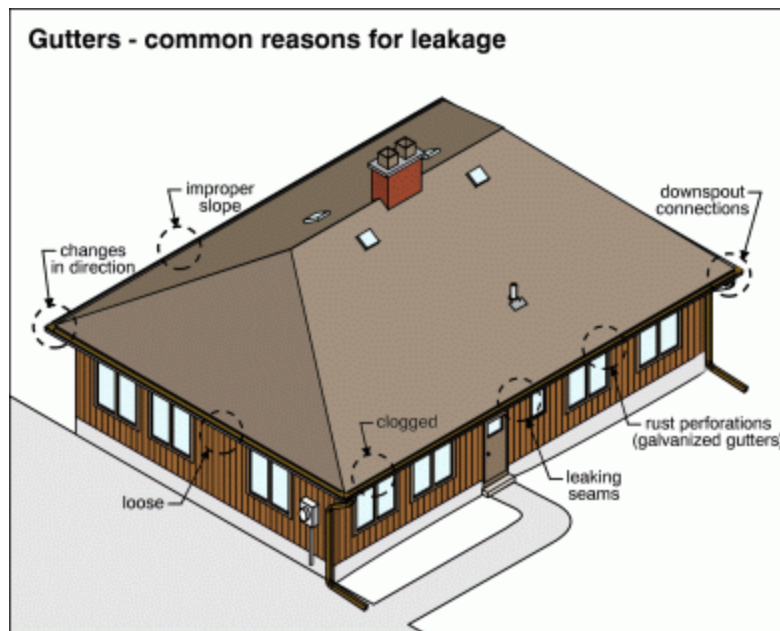
**2. Condition:** • [Leak](#)

**Implication(s):** Chance of water damage to contents, finishes and/or structure

**Task:** Correct Service annually

**Time:** Immediate

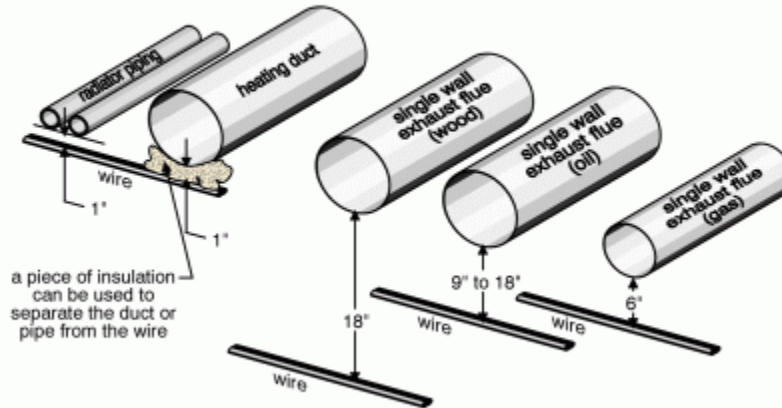
**Wire clearances from hot ducts and pipes**

**5. Condition:** • [Too close to ducts, pipe, chimneys, etc.](#)

**Implication(s):** Electric shock | Fire hazard

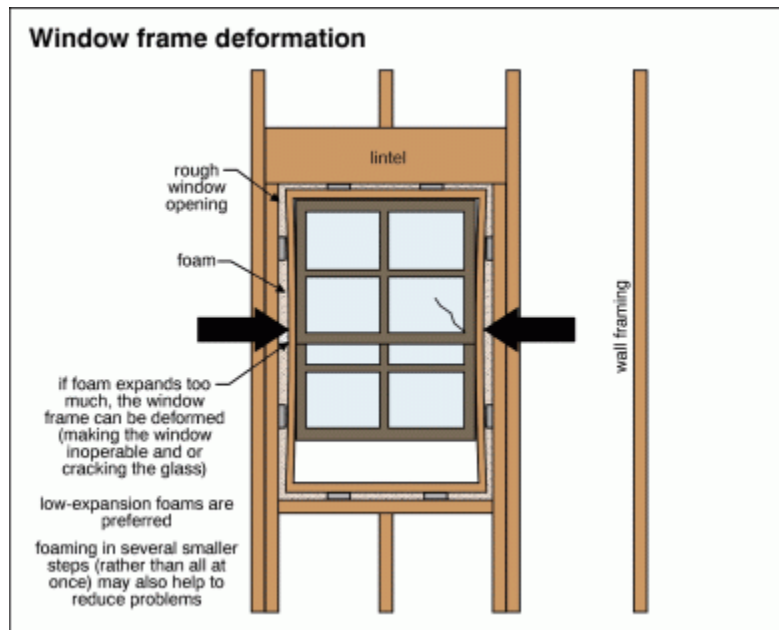
**12. Condition:** • [Deformation](#)

**Implication(s):** Chance of damage to finishes and structure

**Time:** Discretionary

**Cost:** Minor
